AMMRC CTR 74-26

BRITTLE MATERIALS DESIGN, HIGH TEMPERATURE GAS TURBINE

Interim Report Number 5, July 1, 1973 to December 31, 1973

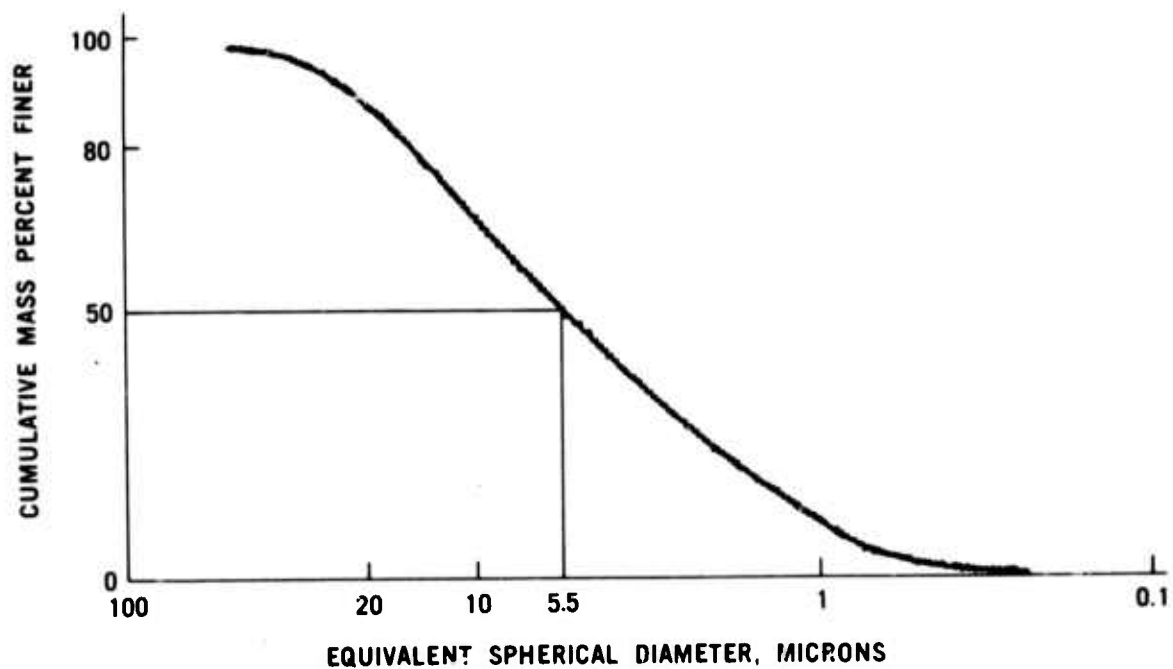
Figure 5.37 Particle Size Distribution of Ball Milled Silicon Metal Powder

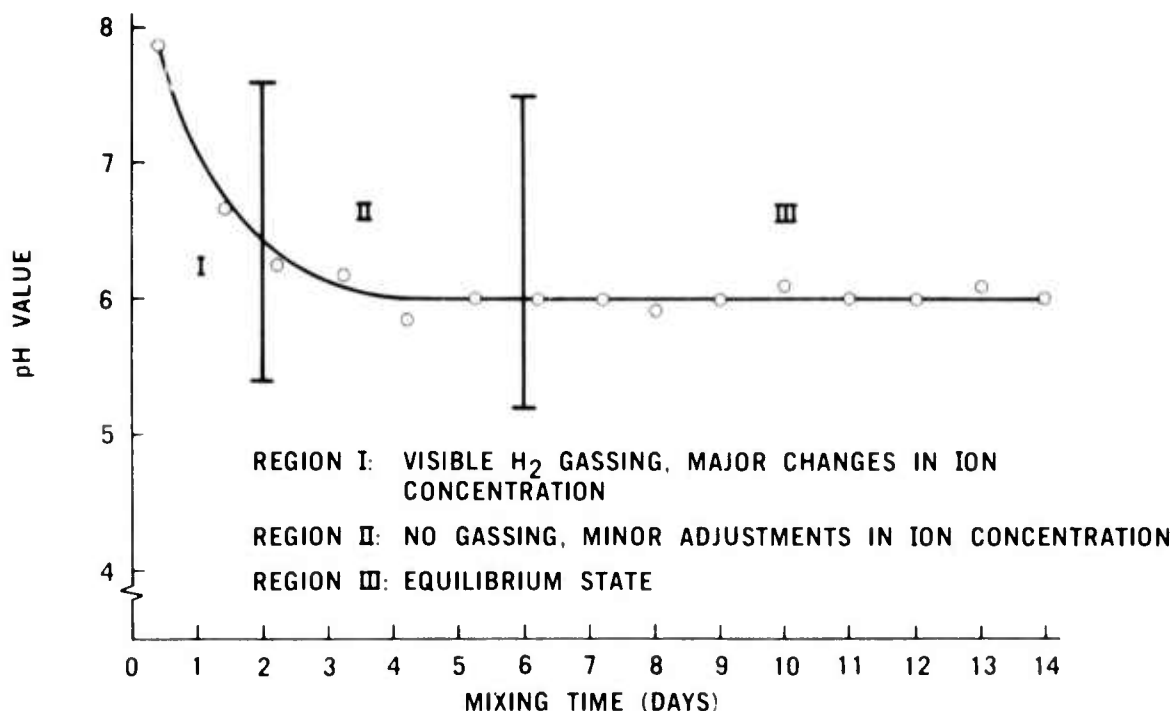
Figure 5.38 Chemical Stability of Silicon Metal Slip and Water-Deflocculant System at Constant pH

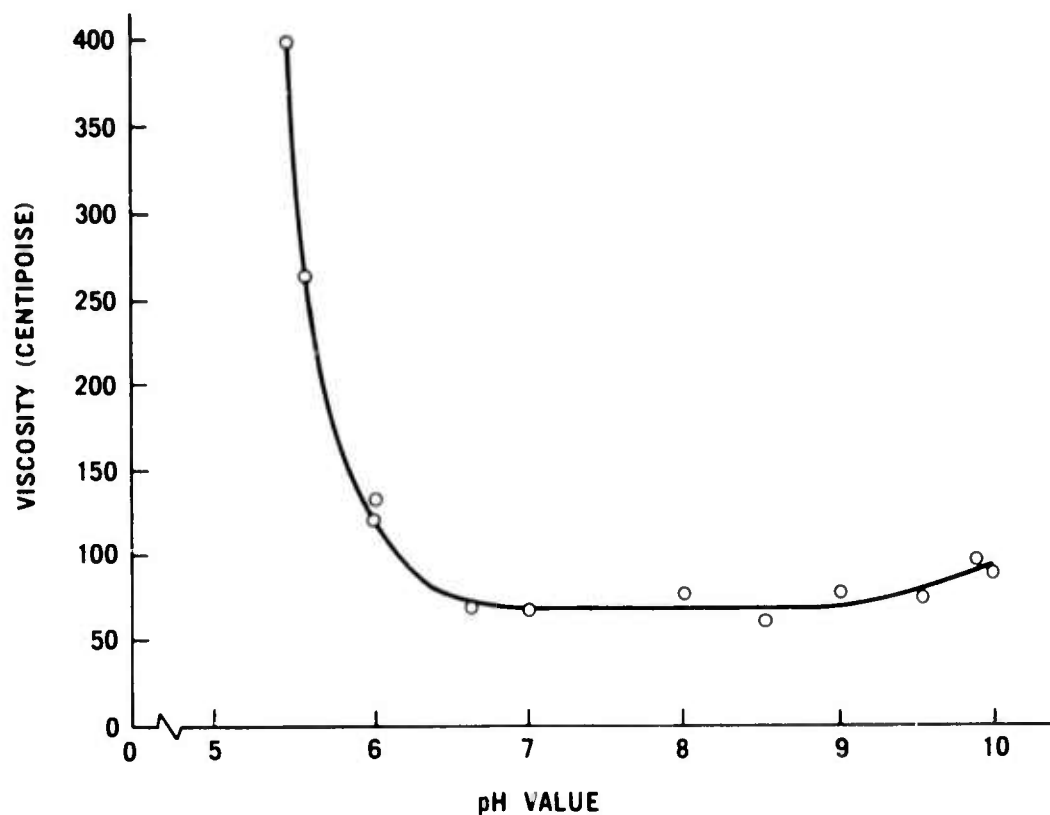
Figure 5.39 pH - Viscosity Relationship of Silicon Metal Slip

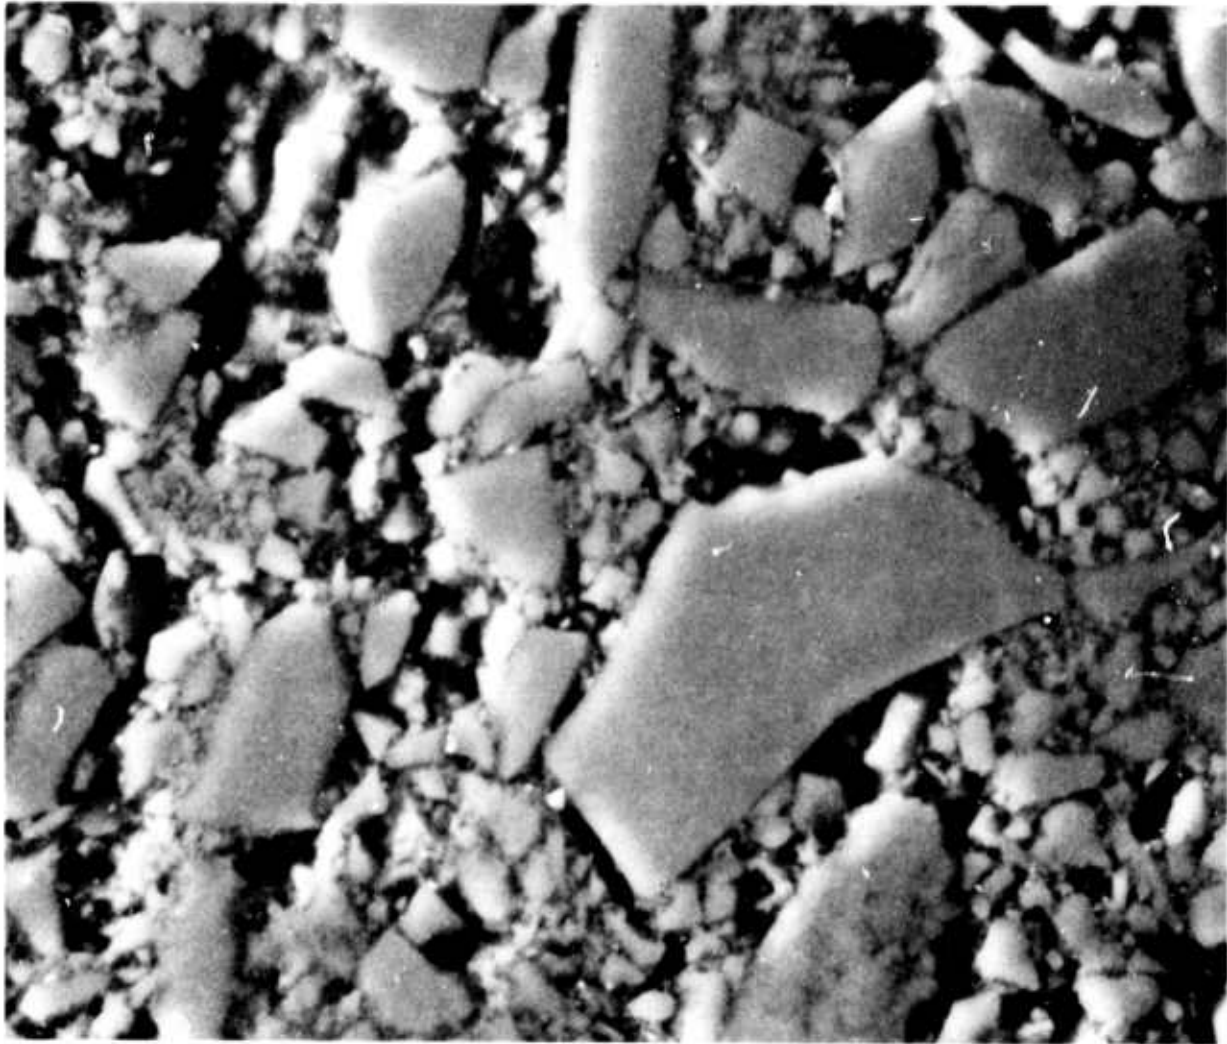
Figure 5.41 Microstructure of a Heat Treated Silicon Metal Slip Cast Specimen Which Has a Density of 1.82 gm/cm^3 (800 x)

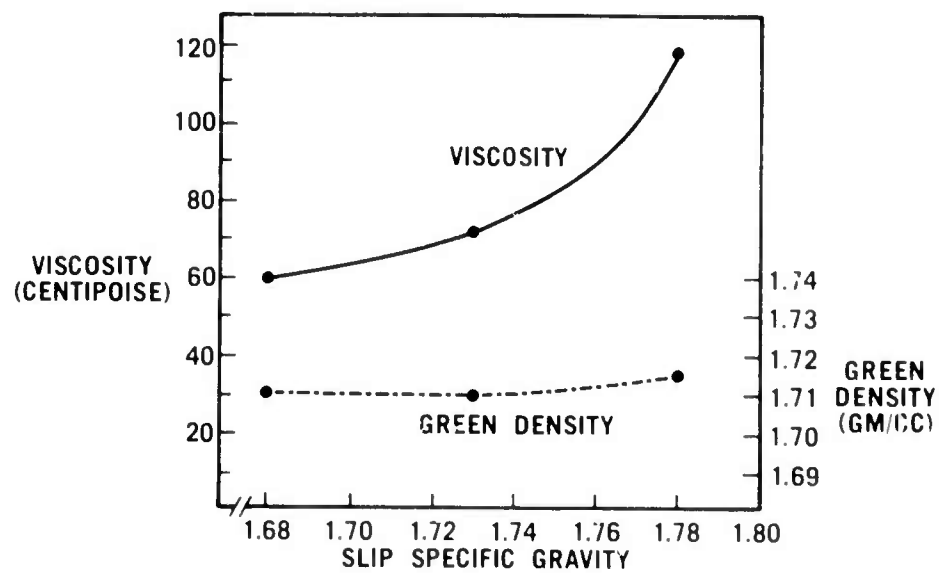
Figure 5.42 Effect of Slip Dilution on Slip Viscosity and Green Density of Silicon Nitride

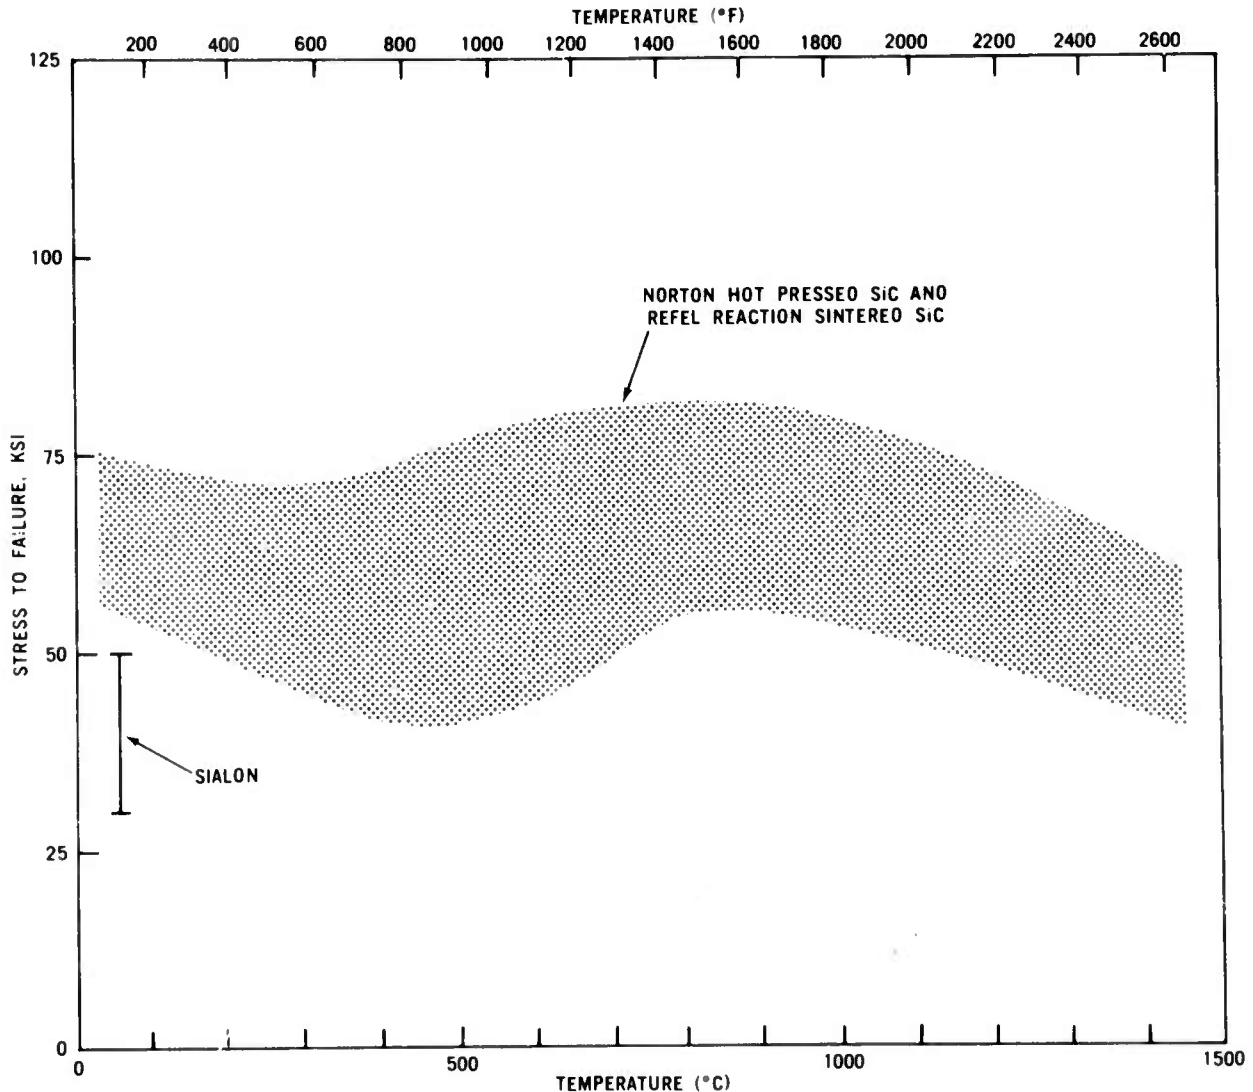
Figure 5.45 Flexural Strength Ranges of Silicon Carbide Materials and Sialon

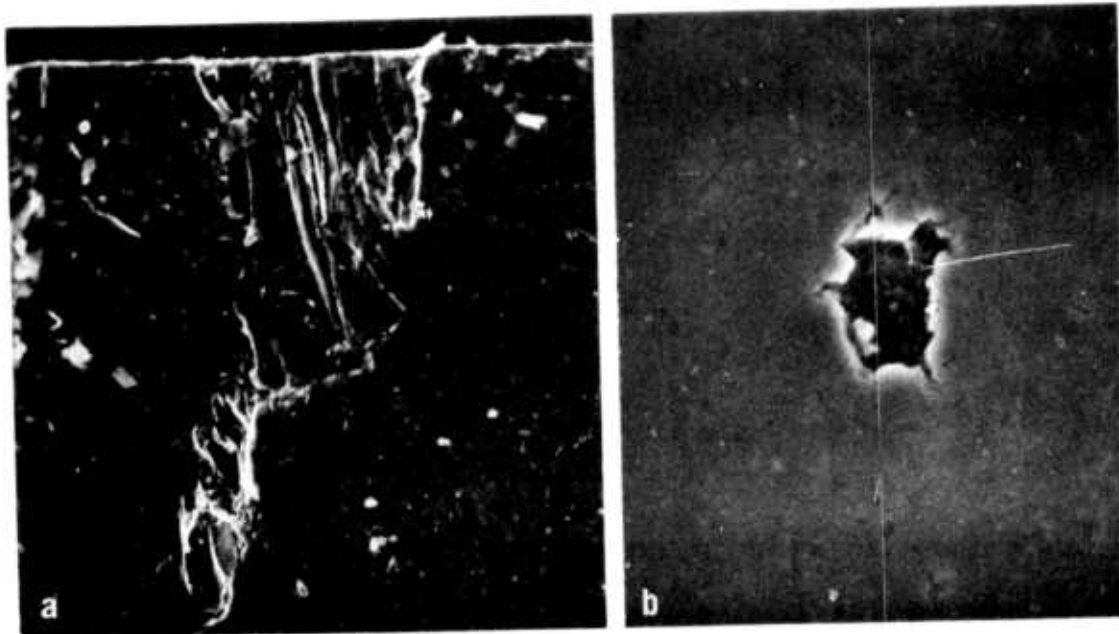
Figure 5.46 Typical Flaws at (a) The Fracture Face and at (b) on the Polished Tensile Surface Reaction Sintered Silicon Carbide

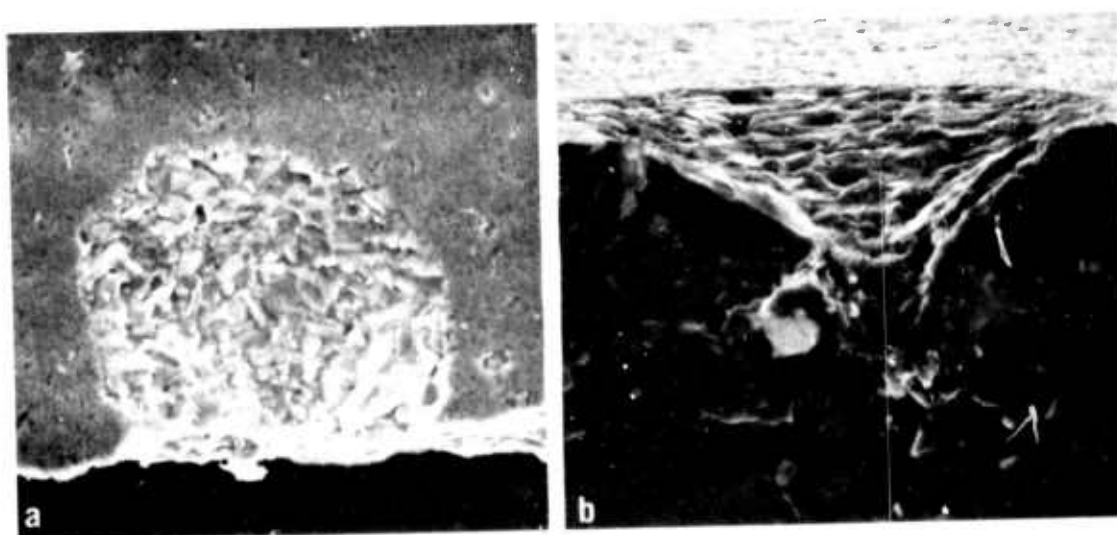
Figure 5.47 Flaw in Reaction Sintered Silicon Carbide From "Pluck-Out" of Unsintered Material by Polishing; (a) is Perpendicular to the Polished Surface, (b) is the Appearance on the Fracture Face

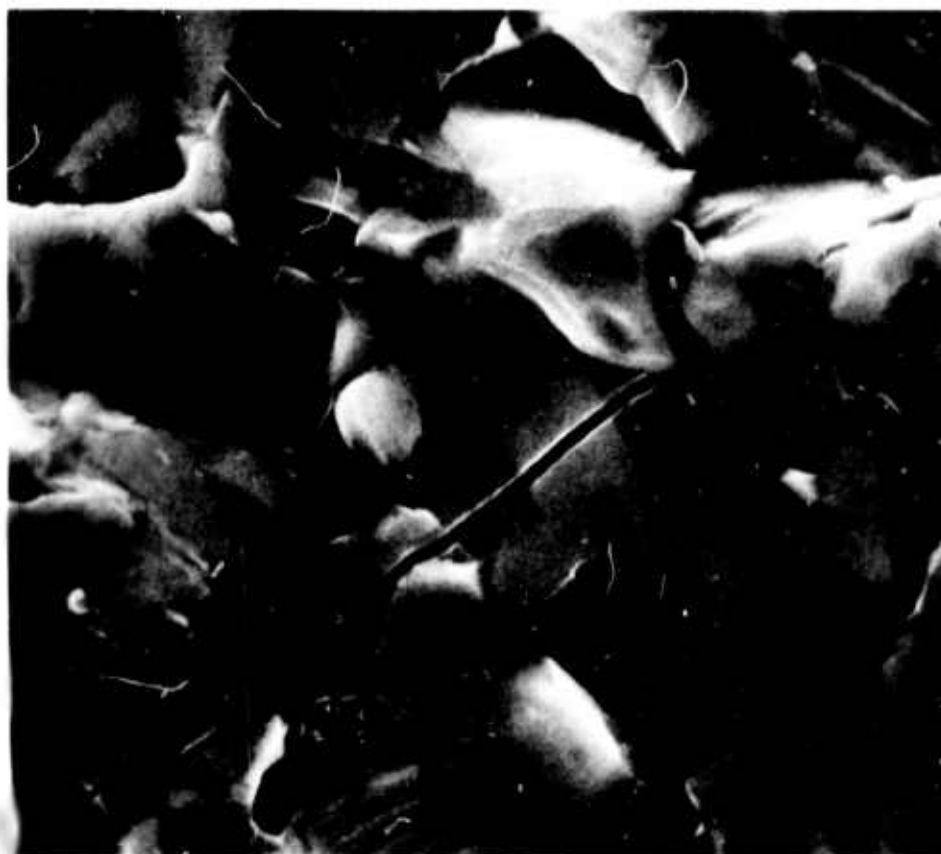
Figure 5.48 Transgranular Crack on the Fracture Surface of Reaction Sintered Silicon Carbide

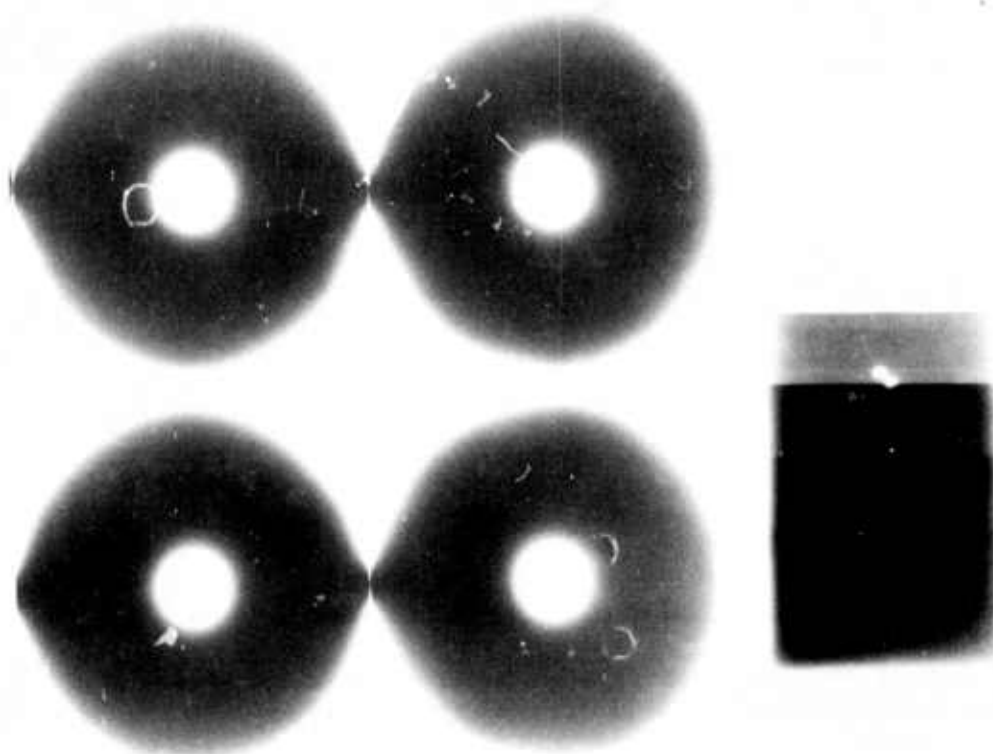
Figure 5.49 Radiograph of High Density Inclusions in Hot Pressed Silicon Nitride

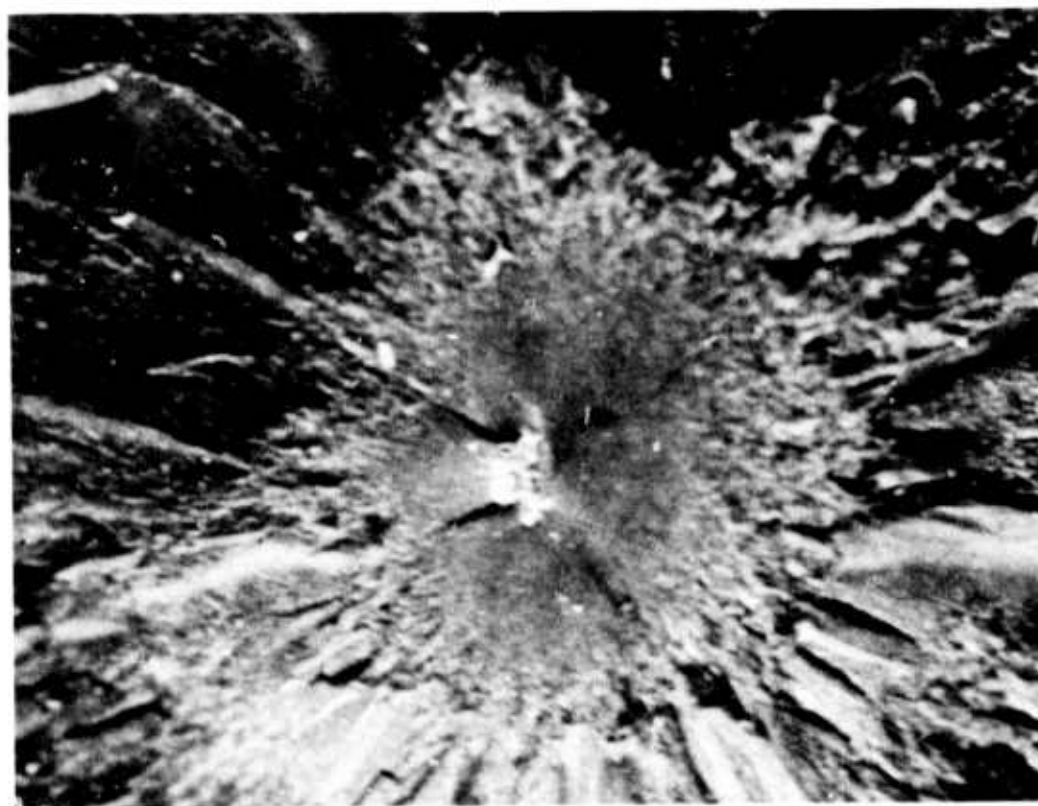
Figure 5.50 Inclusion Type Flaw Observed in Dense Silicon Nitride Spin Disk After Testing

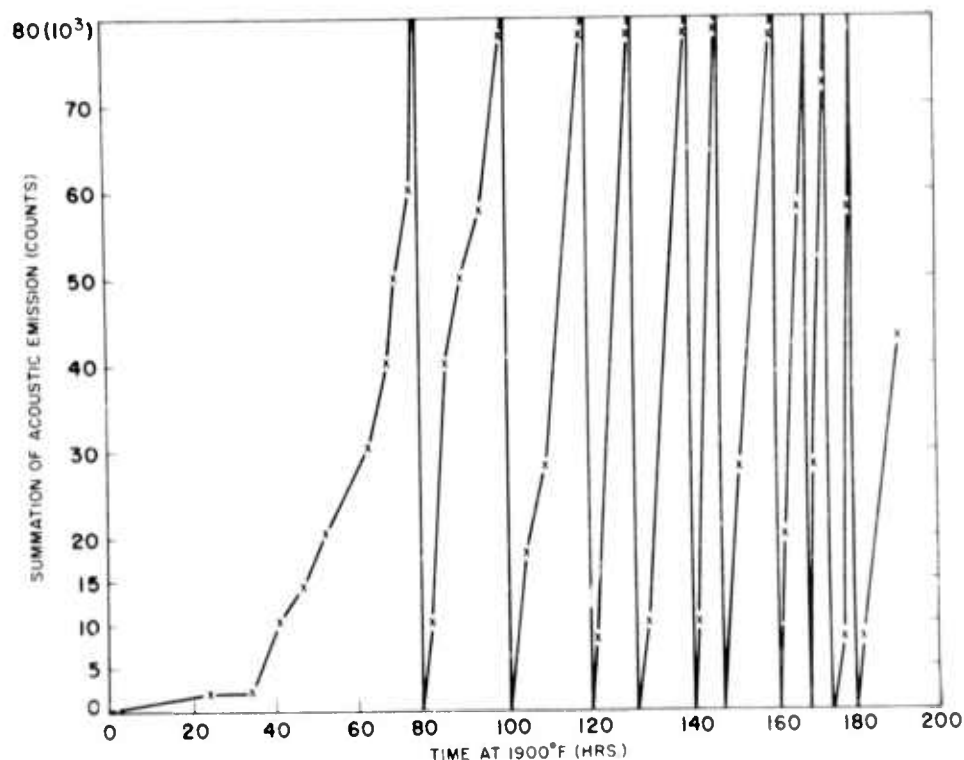
Figure 5.58 Stator Acoustic Emission Response vs Time at 1900°F, Summation Data

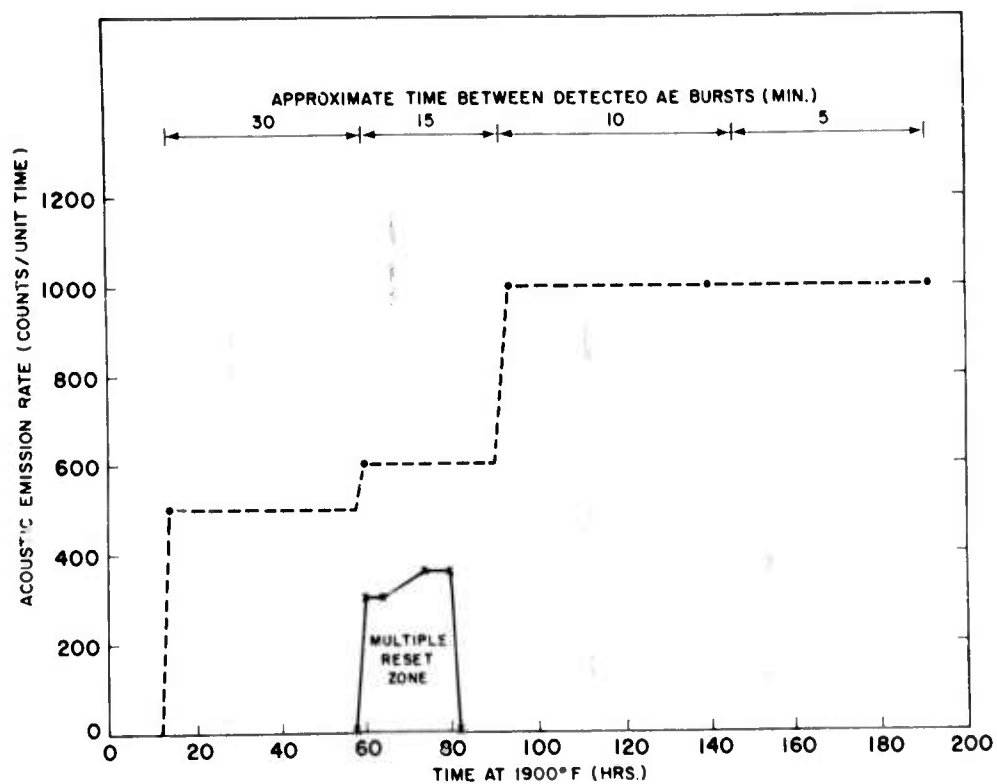
Figure 5.60 Stator Acoustic Emission Response vs Time at Time at 1900°F, Rate Data

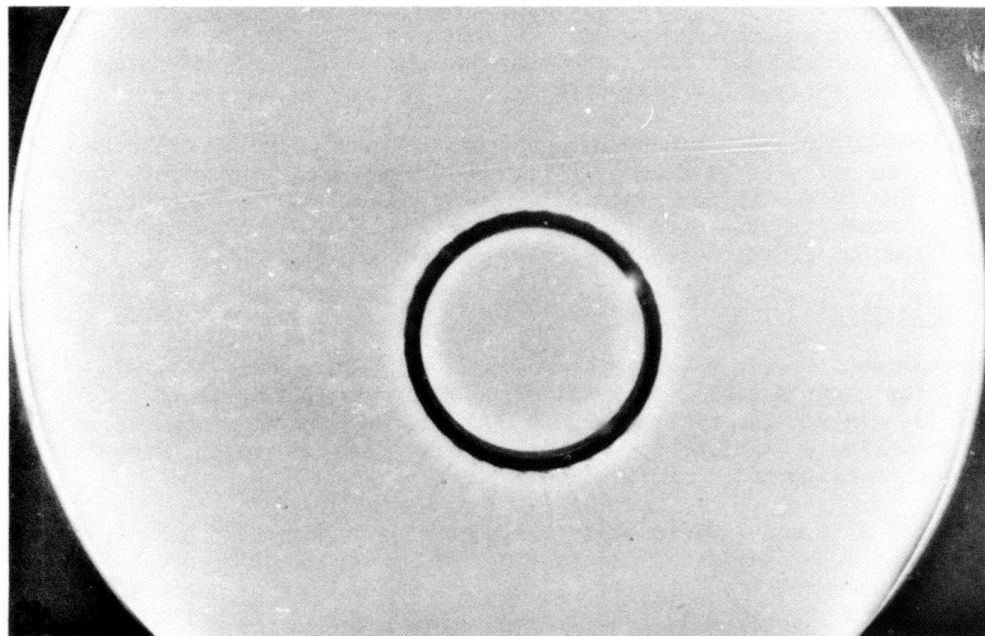
Figure 5.62 Xeroradiograph of Injection Molded Blade Ring and Platform
